Khan, FN, Daadbin, A, Persson, M and Haider, J (2014) Development of AlTiN coated carbide bandsaw for machining titanium-17 alloy. International Journal of Surface Science and Engineering, 8 (1). pp. 11-27. ISSN 1749-785X

# **Development of AlTiN Coated Carbide Bandsaw for Machining Titanium-17 Alloy**

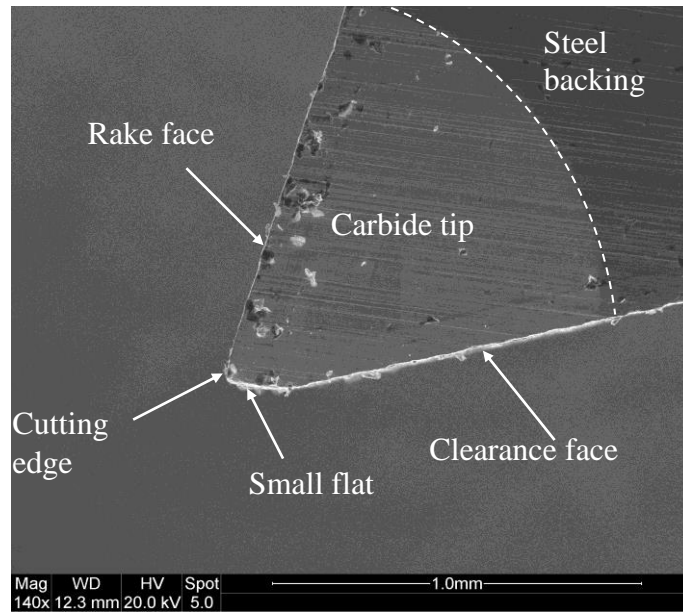
Figure 1. Bandsaw tooth geometry

Tungsten carbide tipped bandsaw teeth were used for the machining tests. A picture of bandsaw tooth geometry is presented in Fig. 1. It would be interesting to note that the bandsaw teeth were honed to make small flat on the clearance side. The geometrical features of bandsaw teeth employed for the machining tests were characterised and presented in Table 3. A number of single bandsaw teeth were coated with AlTiN coating in an arc evaporation system at a deposition temperature of approximately 450 °C.

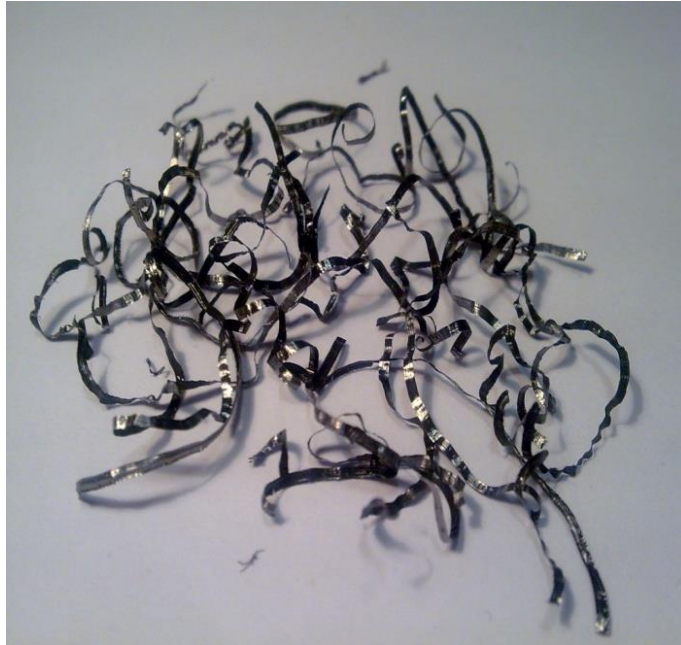
Figure 2. Optical image showing the chips formed during bandsawing of Ti-17 alloy ( $\times 10$ )

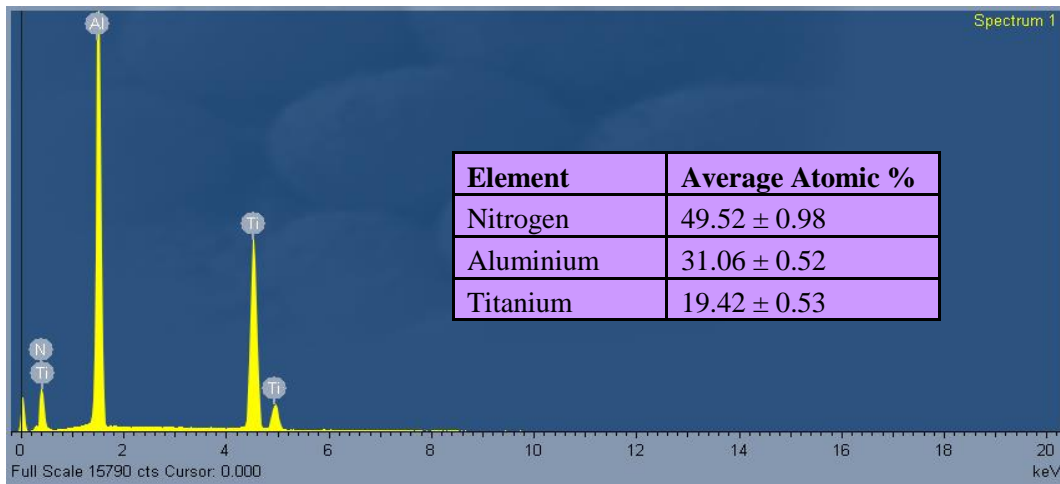
EDX analysis showed that atomic percentage of the elements in AlTiN coating was very close to stoichiometric value (Fig. 3). The atomic percentage of Al (62.13 at %) was higher than that of Ti (38.84 at %). AlTiN coating possesses better properties than aluminium-free TiN coating and the higher is the ratio of aluminium to titanium in the coating, the better are the properties. Furthermore, the AlTiN coating with high aluminium content (up to 65 to 67 at%) have shown improved tool life in machining applications (Horling et al., 2005; Arndt and Kacsich, 2003).

Figure 3. Spectra of elemental composition in AlTiN coating obtained by EDX

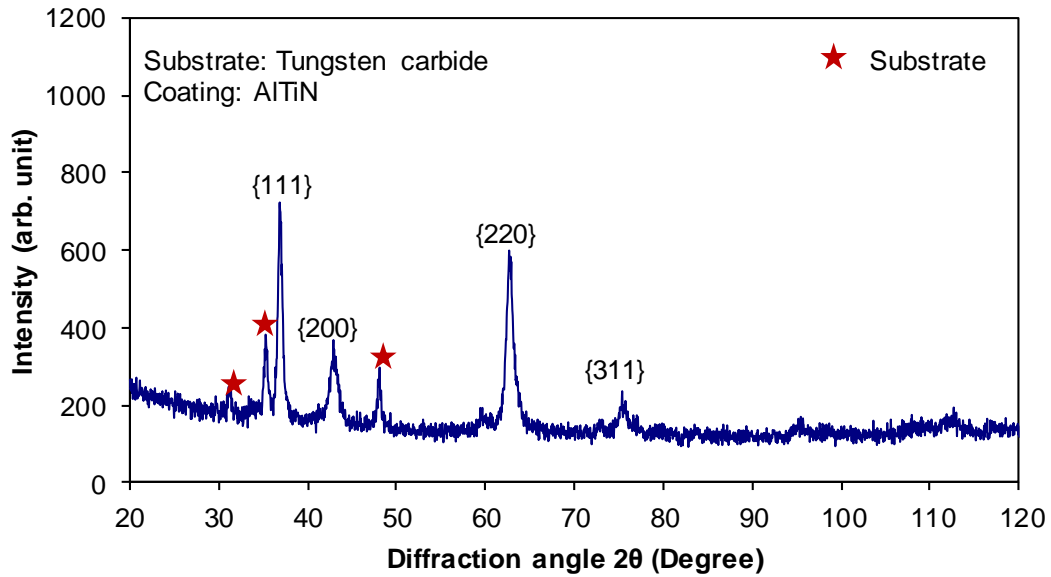
The XRD pattern of AlTiN coating shown in Fig.4 revealed that the coating exhibited face centred cubic (FCC) structure with multiple orientations of (111), (200), (220) etc. and the preferred orientation being in the (111) direction. The narrow peak widths in the spectra indicated that the coating was highly crystalline. Although it was reported in the literature that the increase in aluminium content in AlTiN coating promoted the formation of (200) texture (Kutschej et al., 2005; Cai et al., 2011), it was not observed in the current study. However, a (111) preferred orientation has been noticed in a cathodic arc deposited AlTiN coating with high aluminium content (63 at%) (Chang and Wang, 2007). An aluminium content greater than 70% promotes the formation of a mixed cubic (NaCl) and wurtzite (ZnS) structures, which has a detrimental effect on the mechanical properties of AlTiN coatings (Chen et al., 2012). No signals from wurtzite crystals indicated that the percentage of aluminium in the coating was less than 70%, which was in agreement with the findings in EDX analysis. Therefore, the coating preserved TiN crystal structure with a slight decrease in the lattice parameters. The diffractogram also showed a number of peaks from the tungsten carbide substrate. The average grain size of the crystallites in the coating was calculated to be approximately 34.3 nm, which was in agreement with the work reported in literature on AlTiN coatings deposited by cathodic arc evaporation method (Chang and Wang, 2007).

Figure4. X-ray diffraction pattern of AlTiN coating

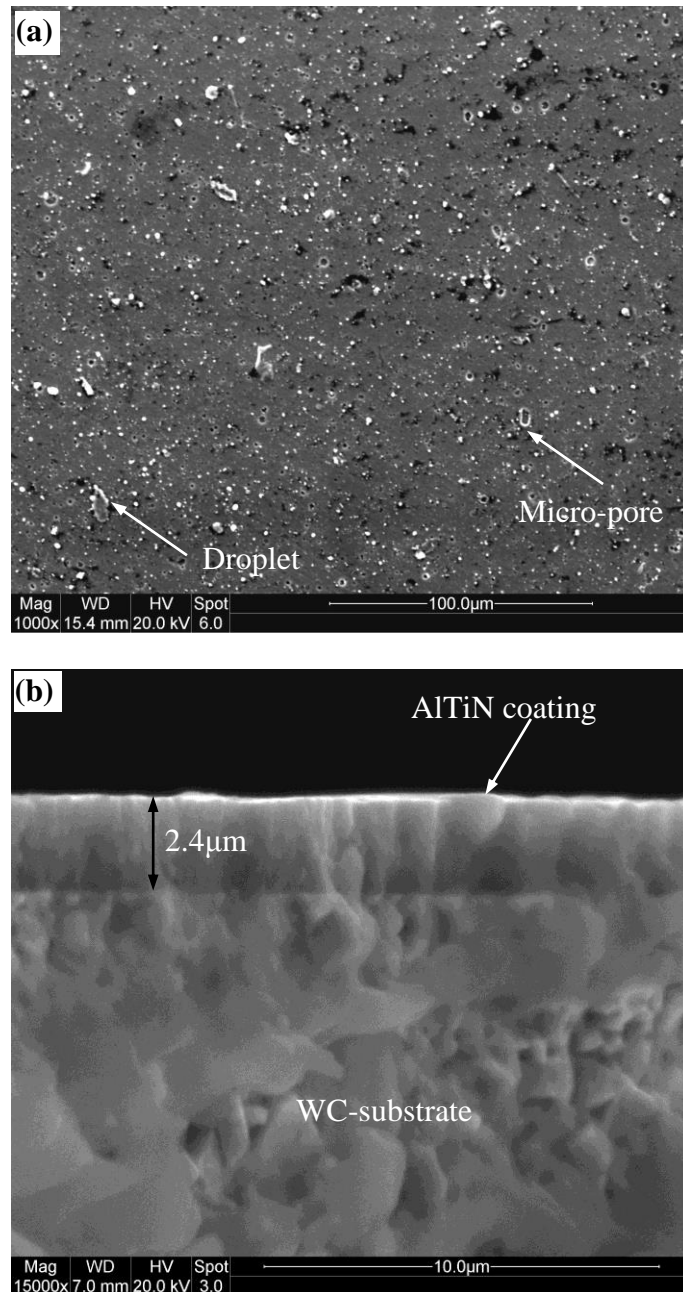
The surface morphology of the coating exhibited micro-pores and droplets, which were characteristics of cathodic arc evaporation process (Fig. 5a). The average size of the micro-pores was between 1-3  $\mu\text{m}$ , whereas the micro-particles were in the range of 2-5  $\mu\text{m}$ . However, the micro-particles can amalgamate and the overall size could increase up to 10  $\mu\text{m}$ . The cross sectional microstructure demonstrated that the coating was deposited as a single layer with a dense and columnar structure (Fig. 5b). Similar microstructures were also reported in the literature for AlTiN coating deposited by cathodic arc evaporation technique (Arndt and Kacsich, 2003). The thickness of the AlTiN coating was calculated to be approximately 2.4 $\mu\text{m}$ , using image analysis software attached to the SEM.

Figure5. SEM images of AlTiN coating: (a) surface morphology and (b) fractured cross-sectional microstructure

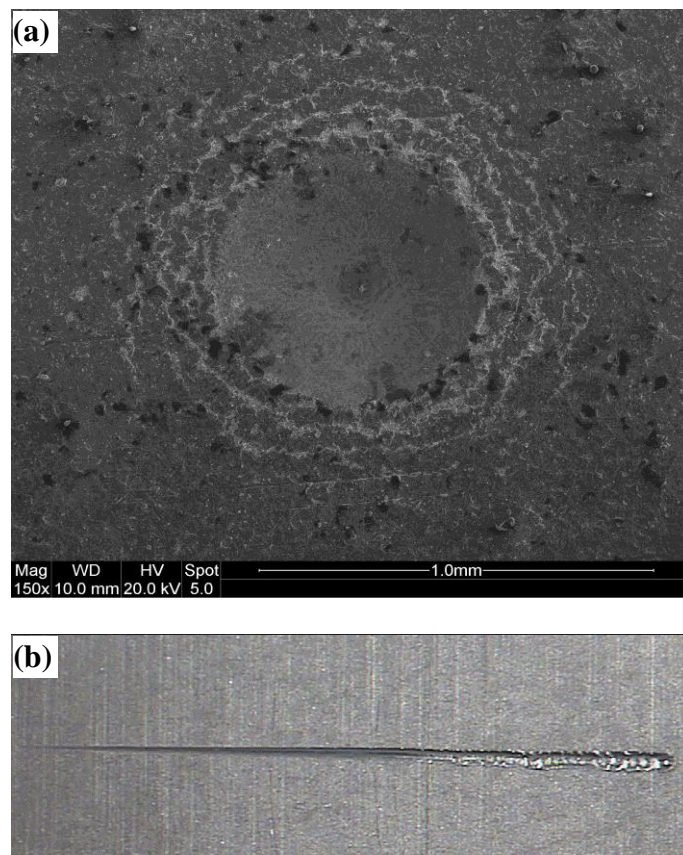
The study of Rockwell C indentation on the coating revealed very small cracks with no delamination of the coating around the indentation (Fig. 6a). This indicated that the coating was tough and well adhered with the substrate (HF1 OR HF2). The higher critical load (~ 75 N) for coating failure found in the scratch test also supported the finding in Rockwell C test. Again, no evidence of brittle fracture around the scratch track ascertained the good toughness of the coating (Fig. 6b).

Figure 6. Micrographs of (a) Rockwell C indentation and (b) scratch track generated in AlTiN coating

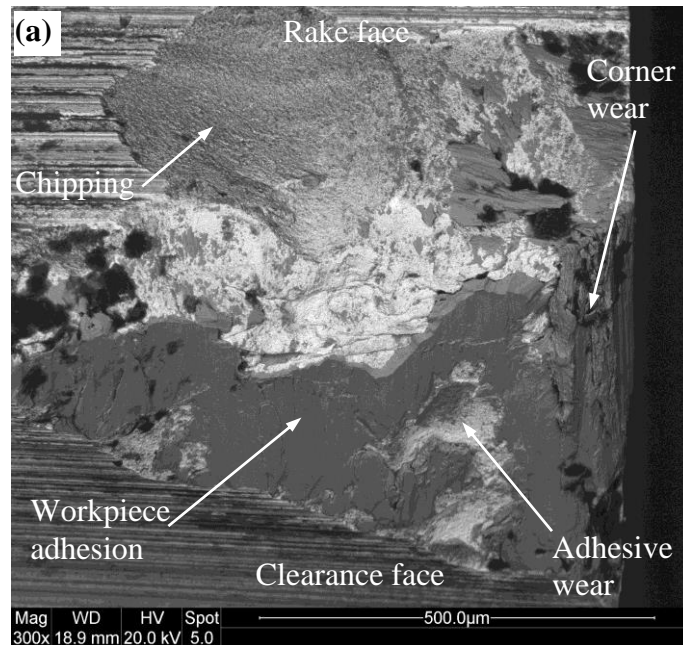
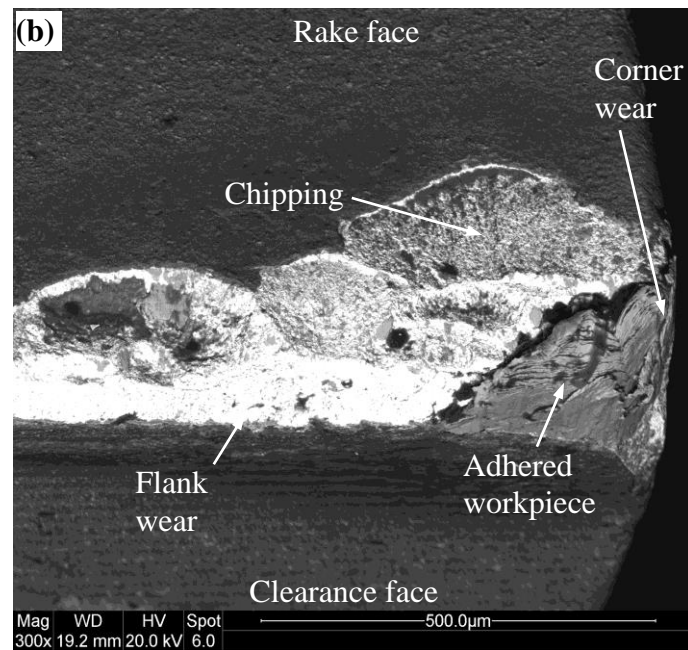
In order to determine the wear and failure modes and to compare the condition of the uncoated and AlTiN coated bandsaw teeth, the machining test was periodically interrupted and finally stopped after cutting 5,700 m. Fig. 7 shows magnified corners of the bandsaw cutting edges. Corner wear and flank wear were identified as the principal wear modes in bandsaw teeth. The maximum wear appeared at the corner of the cutting edge that was engaged with the workpiece and gradually decreased across the thickness of the cutting edge. This could be due to the engagement of the cutting edge at an angle with the workpiece as a consequence of the set geometry (Set and twist angles) of the bandsaw tooth. Furthermore, the width of cut (1 mm) was smaller than the thickness of the cutting edge (1.6 mm).

Figure 7. Magnified images of the corner of bandsaw teeth after 38,000 cuts: (a) uncoated edge and (b) AlTiN coated edge

The SEM images in Fig. 7 exhibited a clear evidence of the workpiece material adhering to the uncoated cutting edge. The high temperature and stress generated during machining caused the welding of the workpiece material to the cutting edge. The process also led to the modification of the cutting edge (Armendia, et al., 2010). The amount of adhering workpiece material could affect the cutting force. When the adhered workpiece layer attained a critical size, it was detached from the cutting edge along with tool material and was removed with the flowing chip. This process would increase the wear and also encourage the chipping of the bandsaw cutting edge.

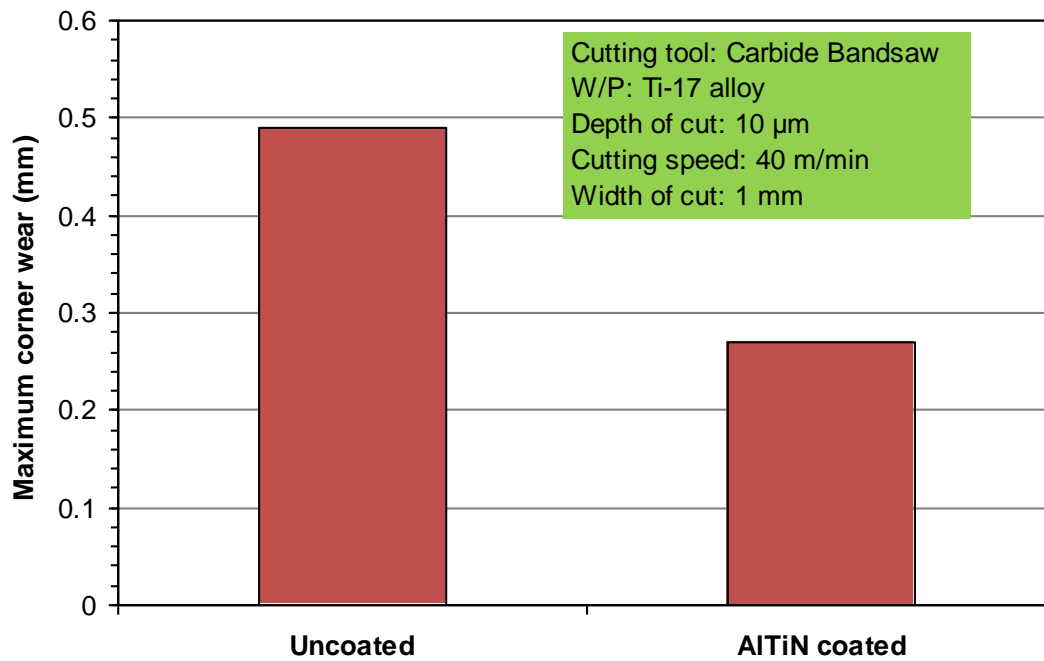
Higher load at the corner would generate higher stress and temperature. This could reduce the yield strength of the tool material and resulted in an accelerated wear at the corner (Che-Haron, 2011). It was evident that the cutting edge in the uncoated tooth was completely damaged with non-uniform wear extending in both rake and clearance faces along with severe corner wear. On the other hand, the cutting edge of the AlTiN coated tooth suffered less wear at the corner and flank face. However, chipping on the rake face was evident in the coated tooth. The corner wear length in the uncoated tooth at the end of the machining tests was almost twice the wear length in the coated tooth (Fig. 8). This means that the tool life was increased by approximately 45% with the incorporation of AlTiN coating on the bandsaw.

Figure8. The comparison of durability between the uncoated and AlTiN coated bandsaw teeth in terms of corner wear

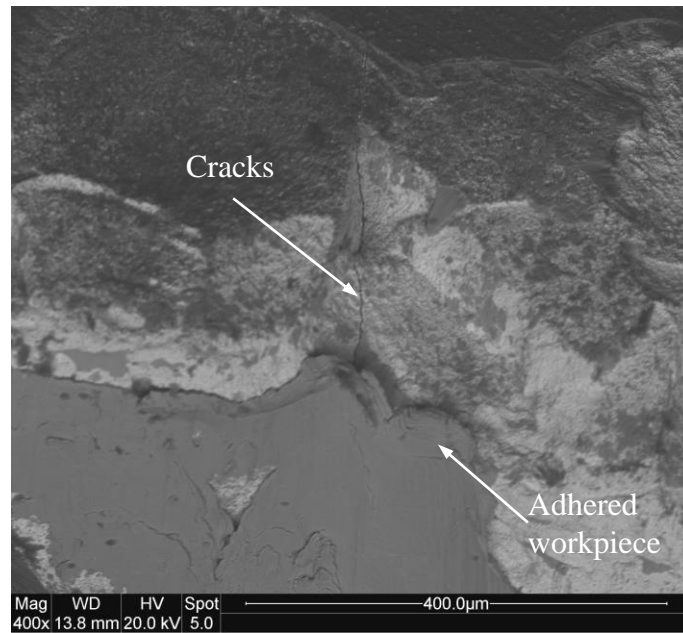
Another failure mode in the form of microcrack was also observed in the bandsaw cutting edge as shown in Fig. 9. The interrupted cutting condition and the generation of high temperature during the bandsawing test could be responsible for the generation of cracks. After the generation of initial cracks, they could further extend into the carbide tip with prolonged machining and finally lead to chipping of the edge. However, it must be stated that chipping could take place without the formation of cracks (Rahim and Sharif, 2007).

Figure9. Bandsaw cutting edge showing cracks

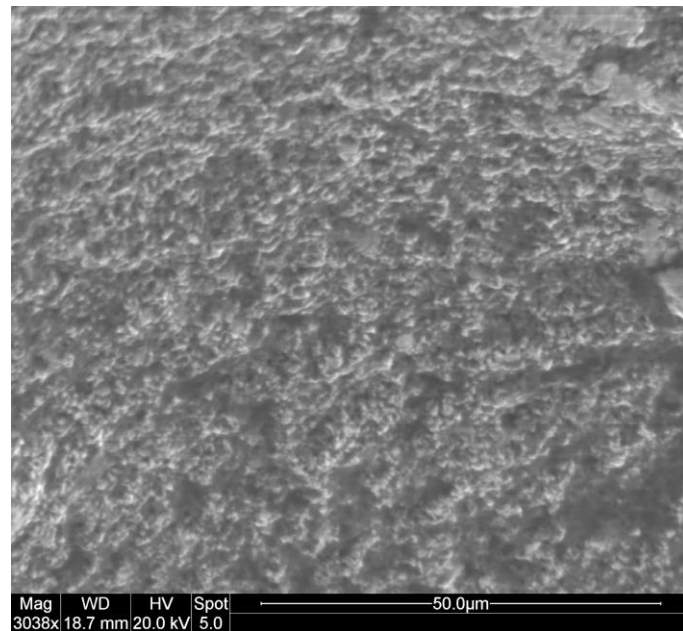
Attrition was also identified as another dominant wear mechanism in the uncoated bandsaw cutting edge. Attrition is defined as the process of removing particles or grains of tool material by adherent chip or workpiece (Jawad and Sharif, 2000; Rahim and Sharif, 2007). The uneven wear on the worn cutting edge evidenced that fragments of the tool had been plucked away by the adhering workpiece material or flowing chip (Fig. 10). The attrition wear process caused a gradual increase of wear in the cutting edges.

Figure 10. SEM picture of bandsaw cutting edge showing attrition wear

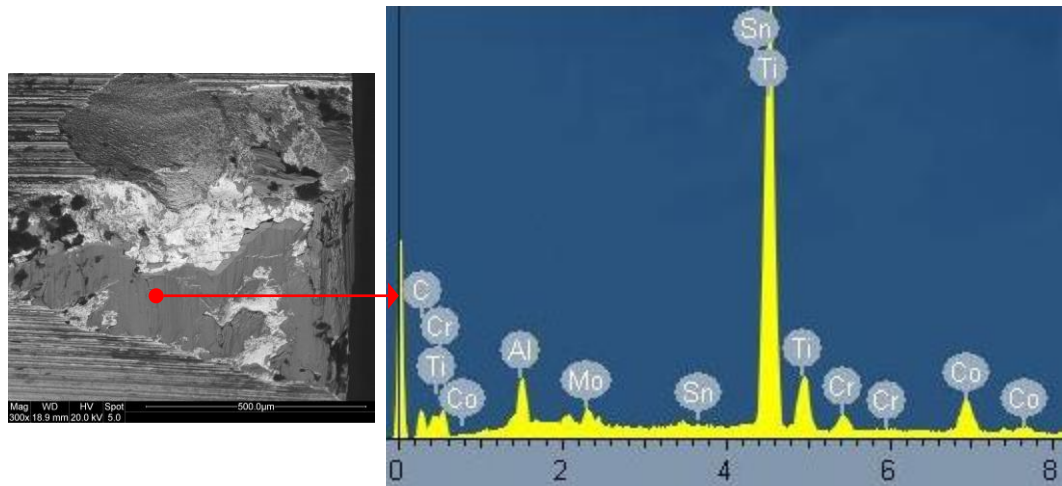
Apart from adhesion and attrition, diffusion wear was identified by the elemental analysis of the workpiece material adhered to the worn tool. The SEM images of the analysed area and the corresponding EDX spectrum are shown in Fig. 11. The presence of carbon and cobalt in the adhered material indirectly indicated that diffusion of the elements from the carbide tool into the workpiece material took place at the tool-chip interface, therefore confirming the diffusive wear. The high stress and temperature at the tool workpiece contact point created a favourable environment for the diffusion of tool elements. Similar results were also observed by other researchers when machining titanium alloy with carbide tool (Su et al., 2006; Jawaaid et al., 2000; Arrazola et al., 2009). Diffusion in tungsten carbide can start at a temperature as low as 400 °C (Jianxin et al., 2008). Even under

Figure 11. EDX spectra of adhering workpiece on the bandsaw cutting edge showing elemental diffusion

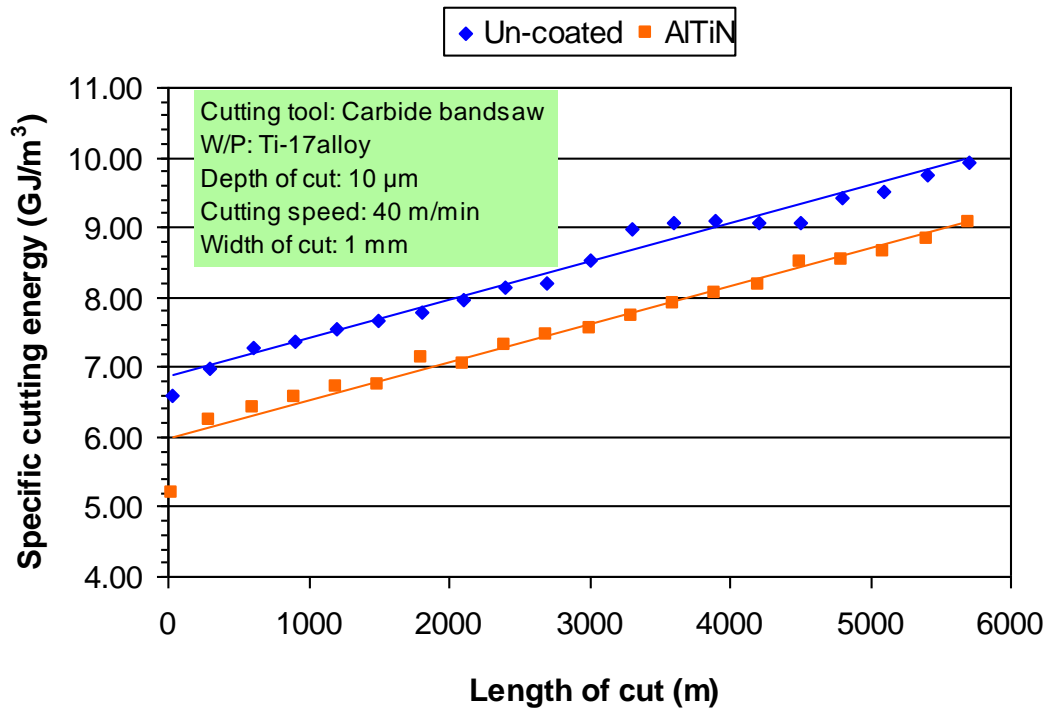
Specific cutting energy ( $E_{sp}$ ) parameter is a measure of the energy required to remove a unit volume of workpiece material and it reflects the efficiency of the cutting process. Moreover,  $E_{sp}$  can be used to correlate various stages of tool wear to the performance of the bandsaw teeth, as it is more sensitive to low depths of cut, which is the case in bandsawing operation (Sarwar et al., 2009). Fig. 12 shows the variation of  $E_{sp}$  with the length of cut produced.  $E_{sp}$  was calculated with the data associated with cutting force and material removal rate. For both uncoated and coated bandsaw teeth,  $E_{sp}$  values increased with the length of cut due to the progressive wear in the cutting edges. Owing to the tool wear and degradation, the cutting edge was modified (i.e., blunting, higher edge radius), which increased the cutting force and hence, higher  $E_{sp}$  (Sarwar et al., 2007). Moreover, the contact length between the clearance face and machined workpiece increased due to the flank wear. This resulted in increased friction and hence, higher cutting force/ $E_{sp}$ .

Figure 12. Comparison of Specific Cutting Energy ( $E_{sp}$ ) with the length of cut for the un-coated and AlTiN coated bandsaw teeth

At the new condition of the uncoated tooth, the  $E_{sp}$  value was measured as 6.2 GJ/m<sup>3</sup> and reached the maximum value of 10 GJ/m<sup>3</sup> at the end of the machining test. However, the  $E_{sp}$  values for the coated tooth always remained less than that for the uncoated tooth. This could be explained by the fact that the coating resisted wear and degradation of the cutting edges due to its high hardness, high oxidation resistance and low coefficient of friction.

It was also interesting to note that a small cyclic trend was observed in the  $E_{sp}$  values with the length of cut. This could be owing to the periodic adherence and removal of workpiece material on the flank face. The modification of the cutting edge due to the adhering workpiece material caused the force/ $E_{sp}$  to increase (Armendia et al., 2010). However, the  $E_{sp}$  decreased again once the original tooth geometry was restored through the removal of adhering workpiece material during machining.
